# > **Dam Safety Inspection Report Meadow Lake Dam (Dam ID No. 1686)**

October 2023  
ECT No. 230639

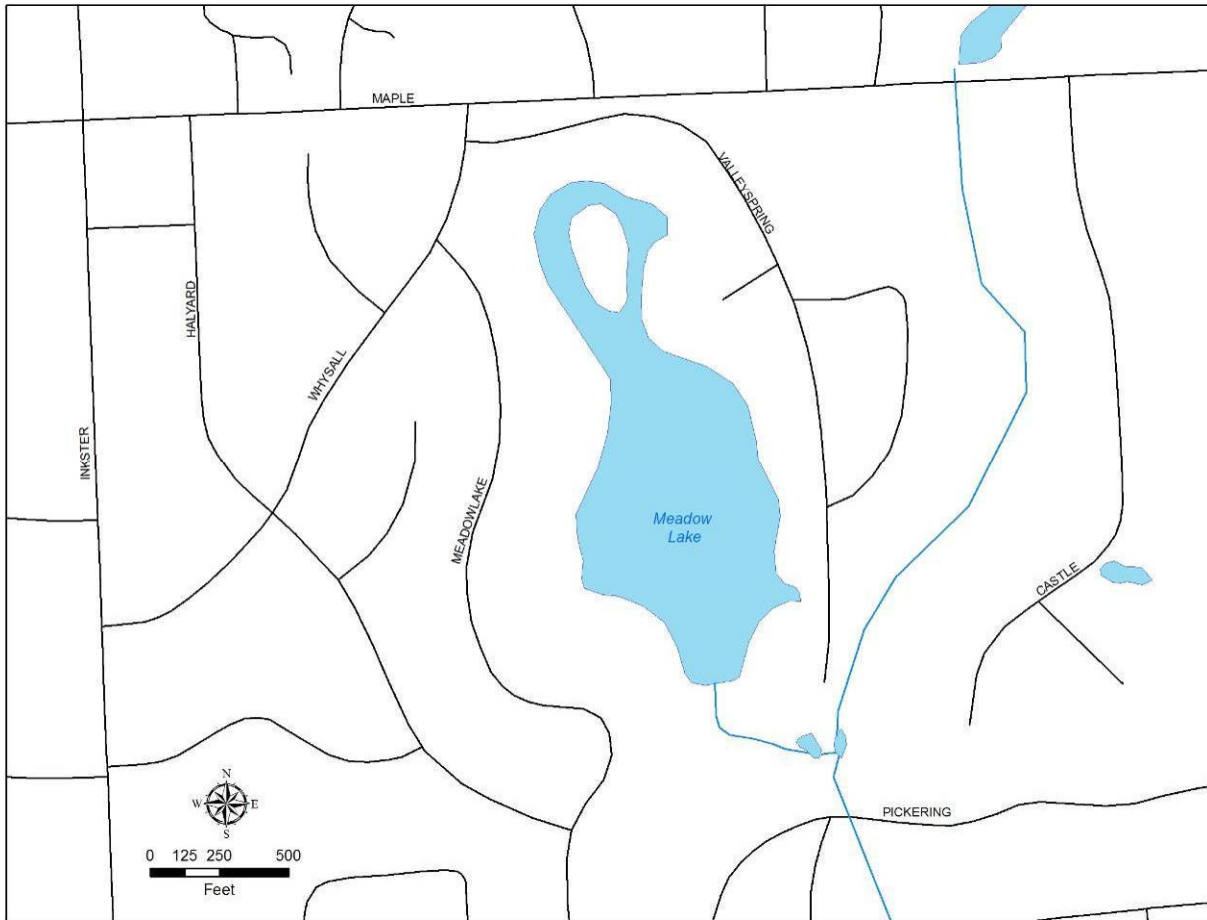
*Meadow Lake Dam Location Map*

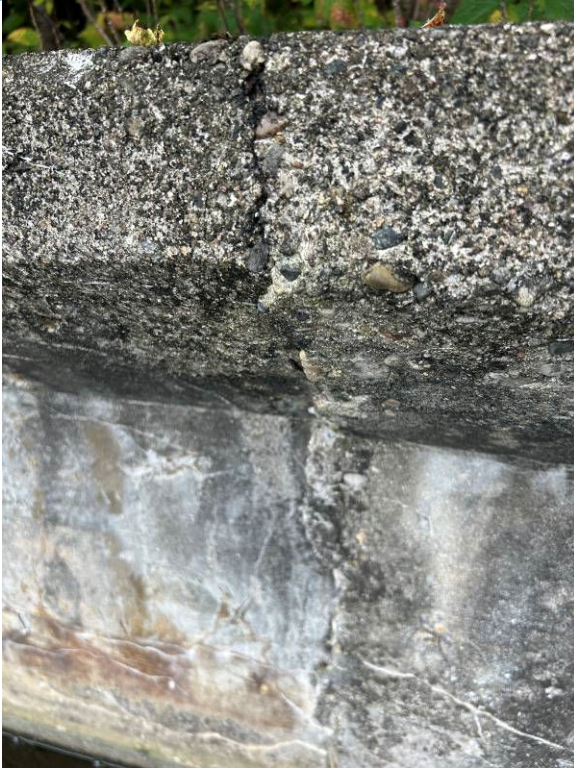
Photo 7:  
Upstream right concrete wall. View of face of wall. Crack extending alongside of wall.

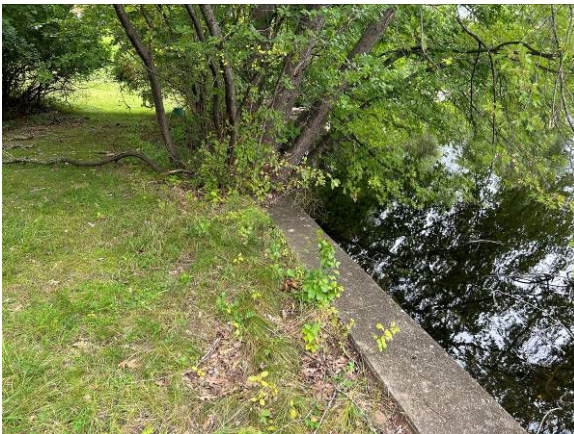
Photo 8:  
Right crest. View looking northwest.

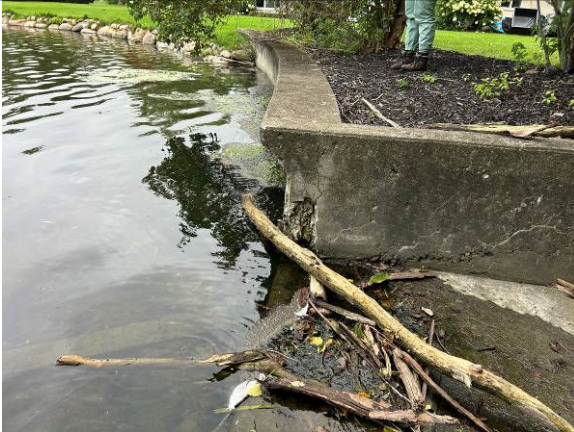
Photo 13:  
Left abutment spalling, cracking, and exposed rebar. Spalling and cracking of concrete at crest.

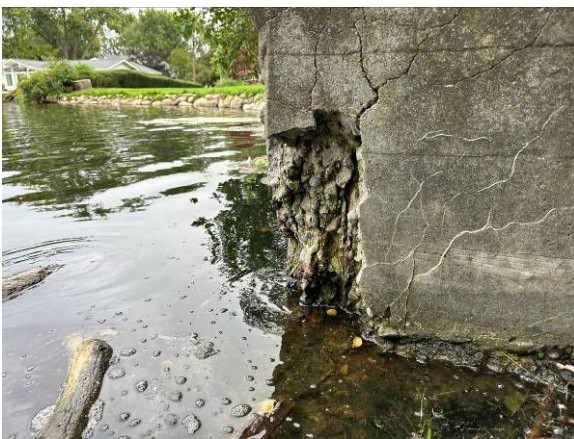
Photo 14:  
Left abutment spalling, rebar exposed.

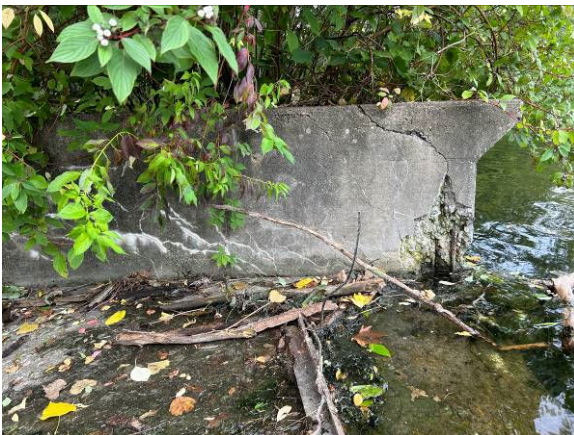
Photo 15:  
Right abutment at crest spalling, rebar exposed. Cracks in vertical concrete walls and horizontal concrete spillway. The crack visible near the upstream edge of the horizontal spillway inlet apron extends across the entire apron.

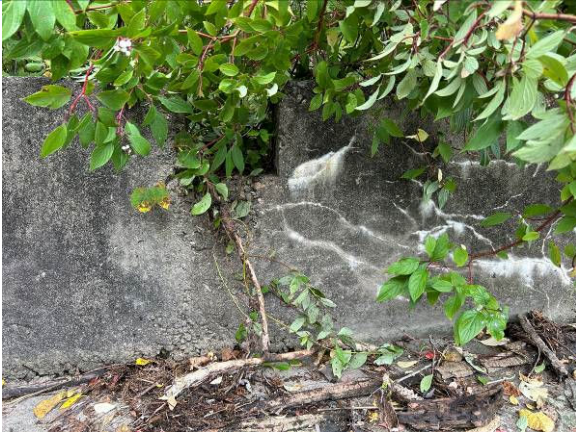
Photo 16:  
Right abutment, concrete wall spalling and cracking.

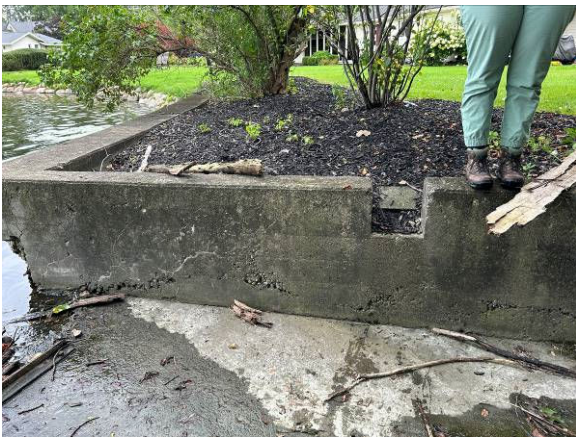
Photo 17:  
Left side of spillway concrete wall spalling and cracking. View looking east.

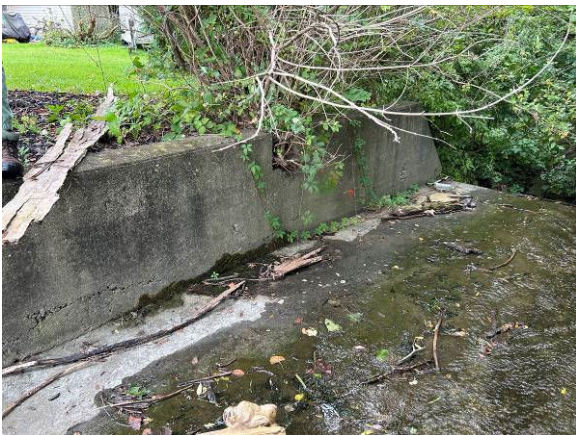
Photo 18:  
Left side of spillway. View looking southeast.

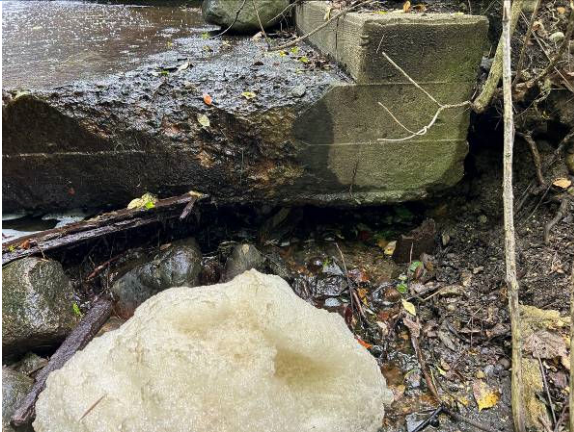
Photo 25:  
Seepage observed flowing from void space beneath outlet apron. Sparse riprap downstream of apron.

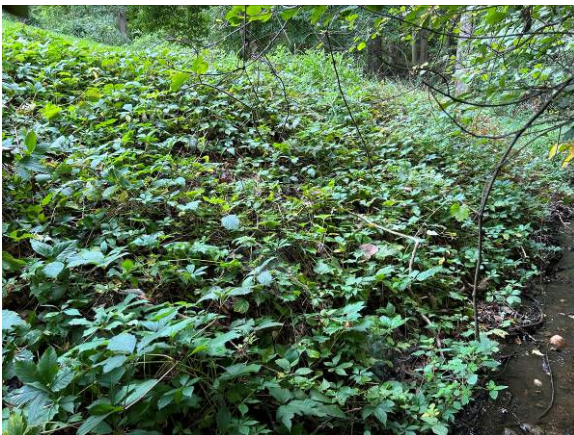
Photo 26:  
Left downstream embankment with good vegetation.
